Falmouth, Maine
Slope Stability Issues
Bayshore/Shoreline Drive

PROJ NO: 11545A	DATE: Sept 2009	FIGURE: 2B
-----------------	-----------------	------------

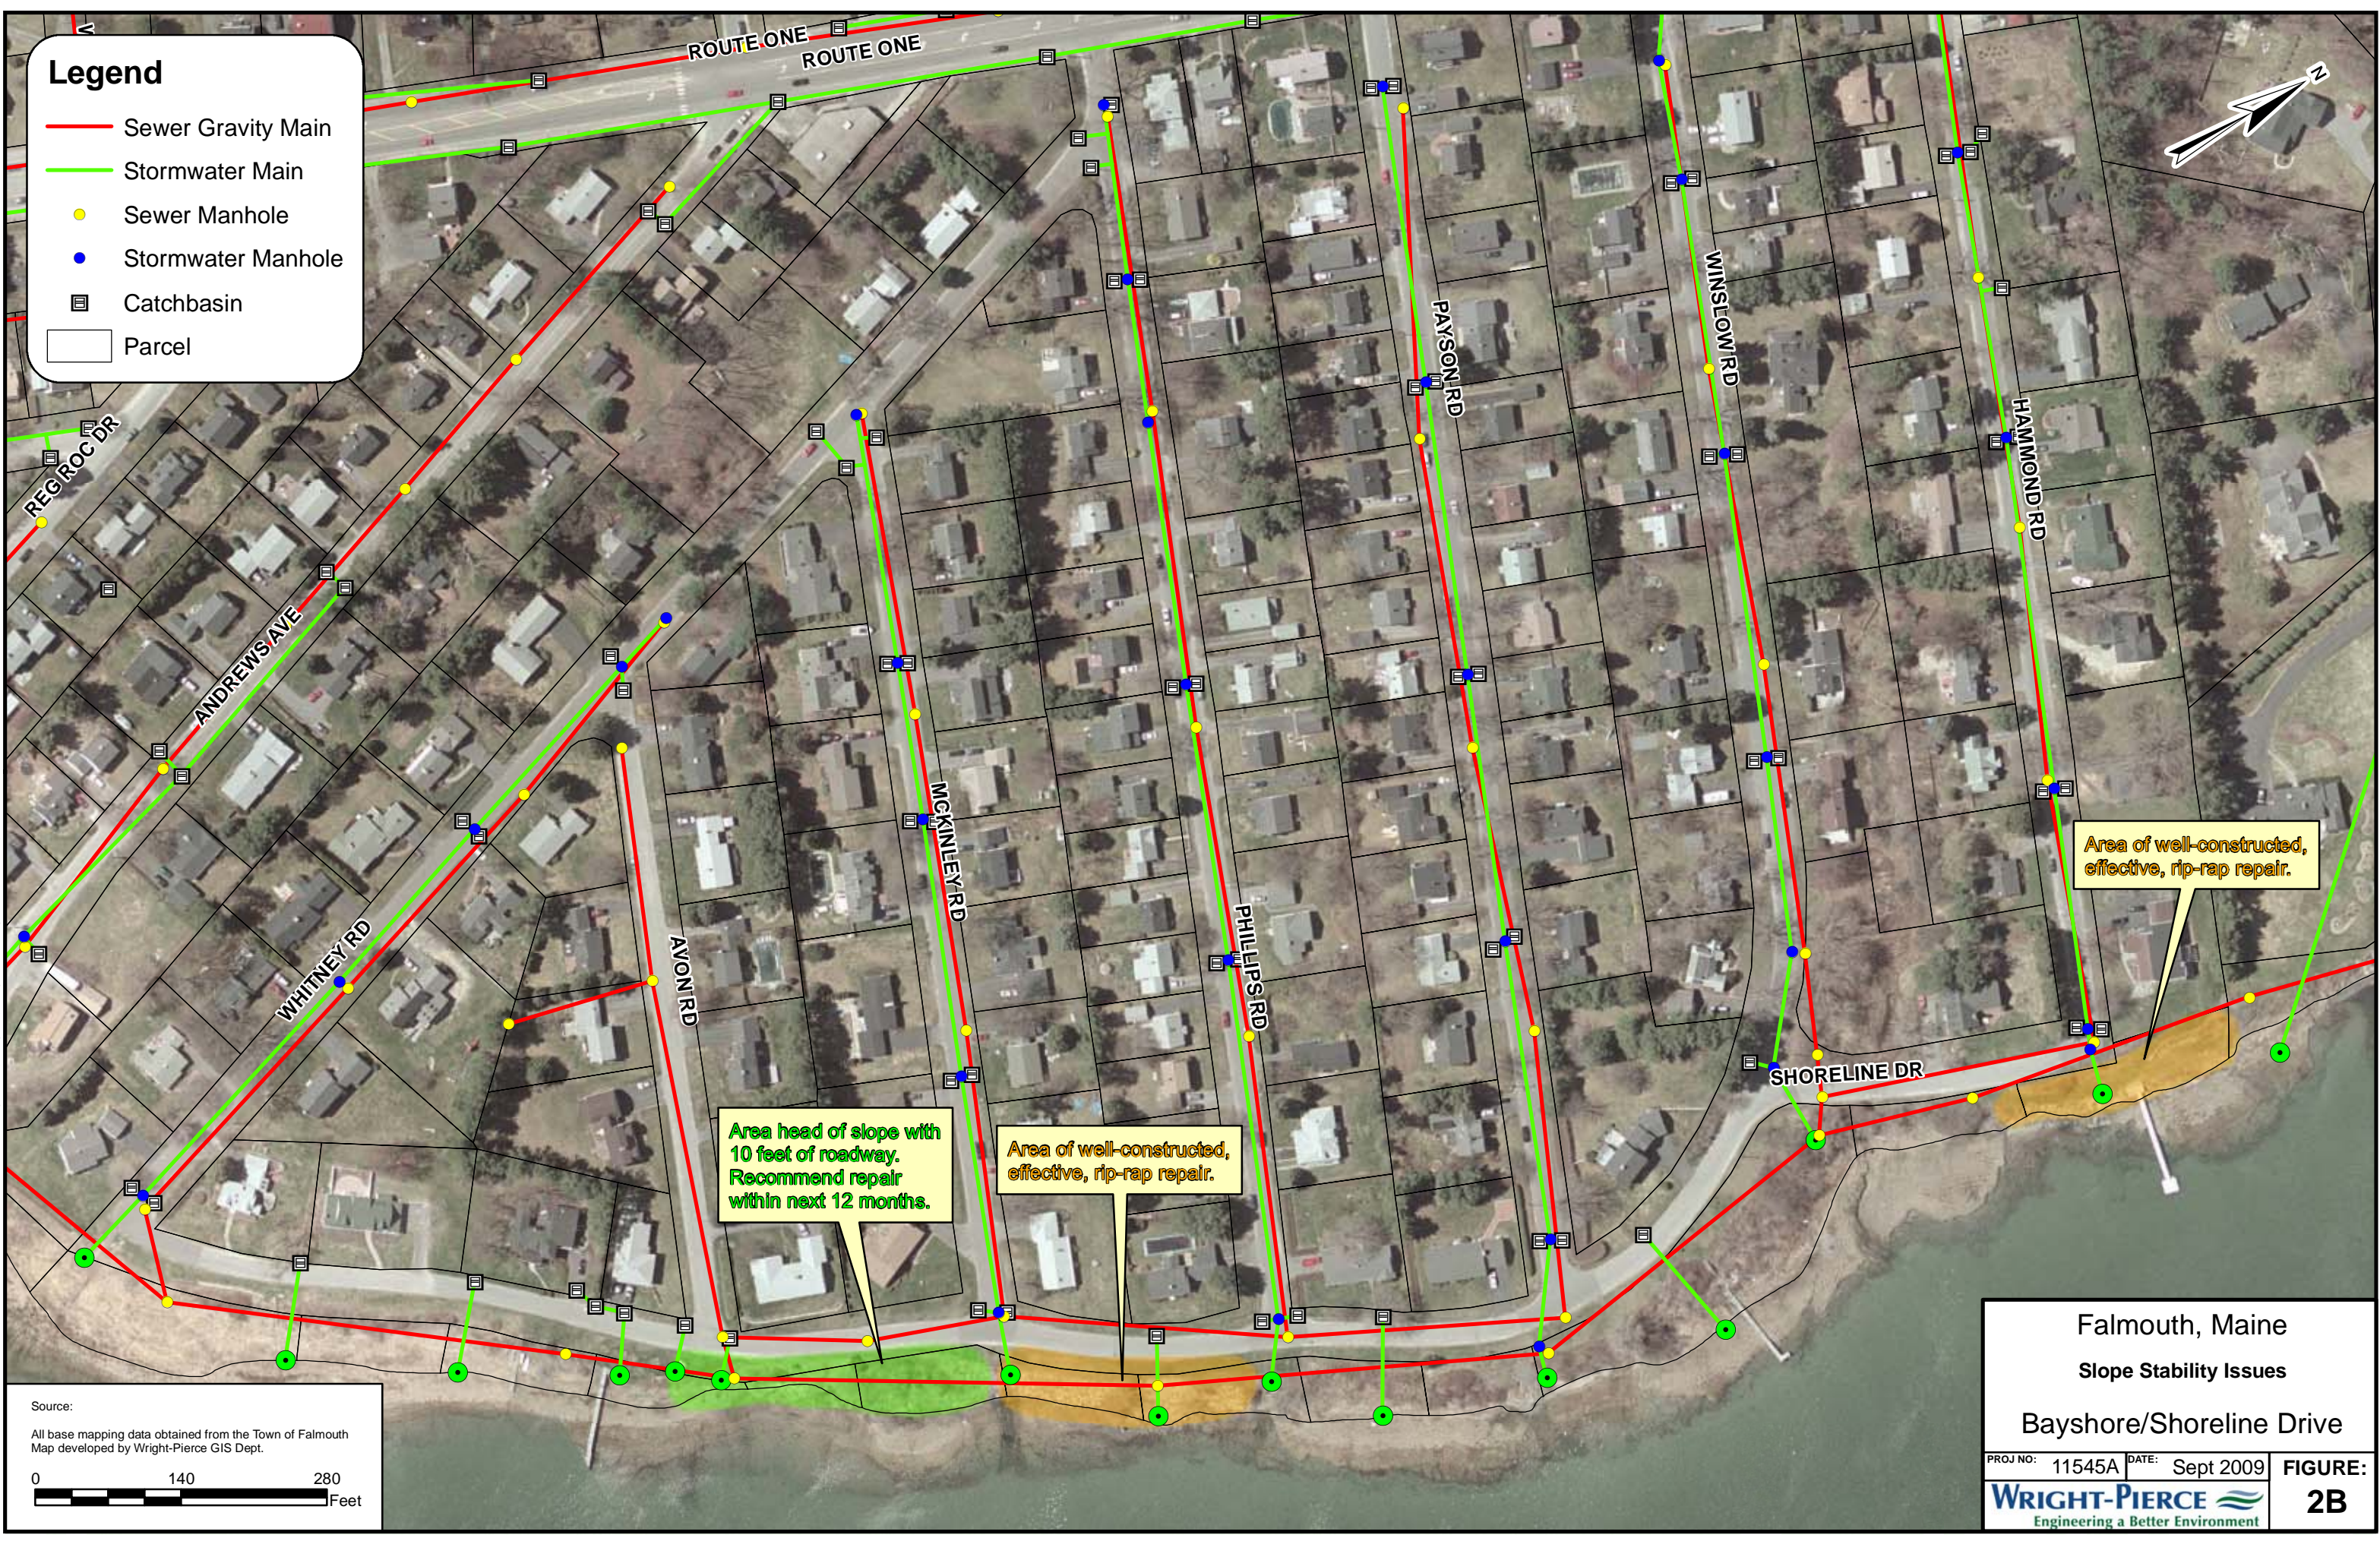
Area head of slope with 10 feet of roadway. Recommend repair within next 12 months.

Area of well-constructed, effective, rip-rap repair.
